# **The Impact Response of Carbon/Epoxy Laminates**

(MSFC Center Director's Discretionary Fund Final Report,  
Project No. 94-13)

*A.T. Nettles and A.J. Hodge*

*Marshall Space Flight Center, Marshall Space Flight Center, Alabama*

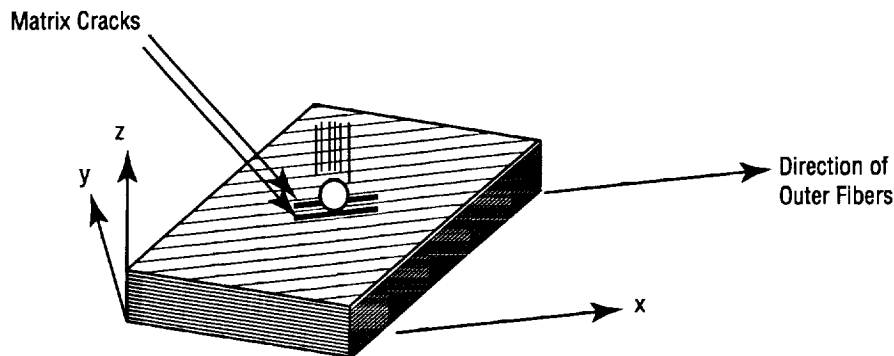
There are three major modes of damage that can be incurred during foreign object impact events. These are matrix cracking, including fiber/matrix debonding; delamination; and fiber breakage. The formation and extent of these damage modes are heavily dependent upon specimen geometry, or more precisely, the ability of the impacted structure to deform. For relatively stiff structures, contact forces will dominate, and for flexible structures, in-plane forces will dominate due to global bending. The contact force generated by the impactor, if sufficiently large, can cause transverse matrix failure in the impacted ply and/or those beneath it parallel to the direction of fibers in each ply, due to the high shear stresses,  $\tau_{yz}$ , that are set up (shown schematically in figure 1).

Figure 1. Top ply cracking due to contact stresses.

As the impactor drives itself into the specimen, the material from the top ply tends to spread the load over a wider diameter, producing matrix cracks slightly away from the impact site in the next-to-the-top ply. As these transverse cracks develop, they become wider apart through the thickness as shown schematically in figure 2. These transverse cracks usually join one another through the acute angle with the adjacent ply via delamination, shown schematically in figure 3. When cross-sectioned, the transverse cracks and delamination will form a characteristic cone shape as noted in references 23–27 (shown schematically in figure 4). The through-the-thickness assimilation of the delaminations will give the characteristic “stair-step” shape, noted in references 28 and 29.

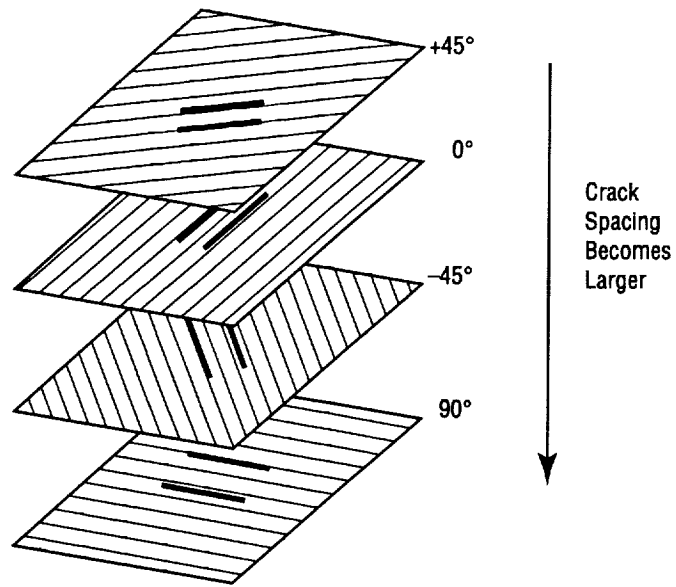
Figure 2. Cracking through other plies due to contact stresses.

For composite laminates that experience large deformations during an impact event, large in-plane stresses can cause damage to form. The intrinsic weakness of a ply perpendicular to its fibers causes the bottom plies of heavily deformed laminates to split along the fibers in that ply, due to the high tensile strains from bending. The transverse shear in the plate will be at maximum near the center of the plate and it has been observed that this region contains the planes of largest delaminations, except when spalling occurs on the nonimpacted face, after an impact event.<sup>29</sup>

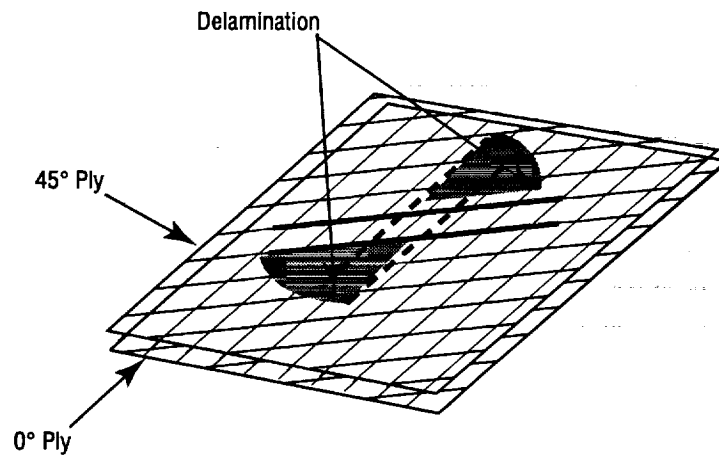
Figure 3. Transverse cracks in adjacent  $45^\circ$  and  $0^\circ$  plies joined via delamination.

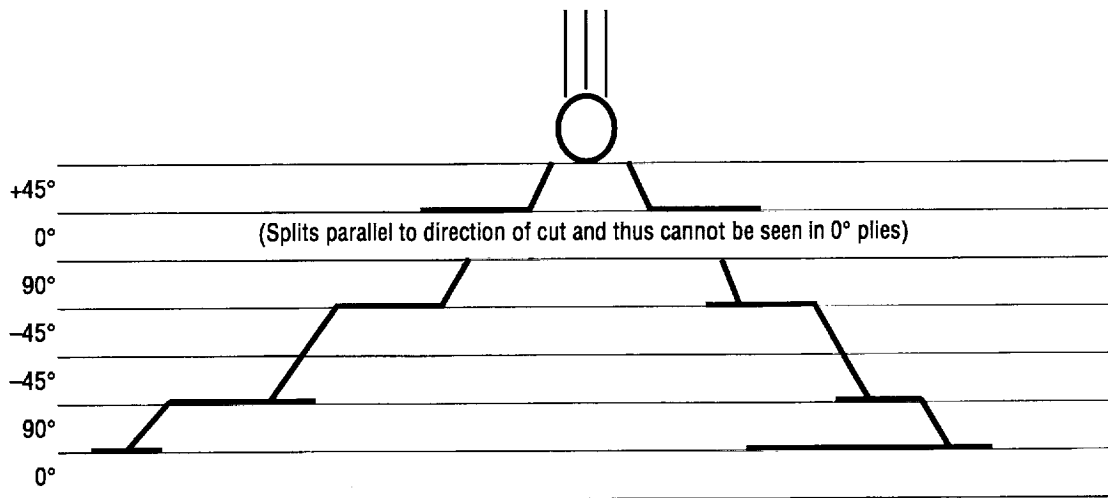
Figure 4. Schematic representation of cross-sectional view of transverse cracks and delaminations due to contact forces.

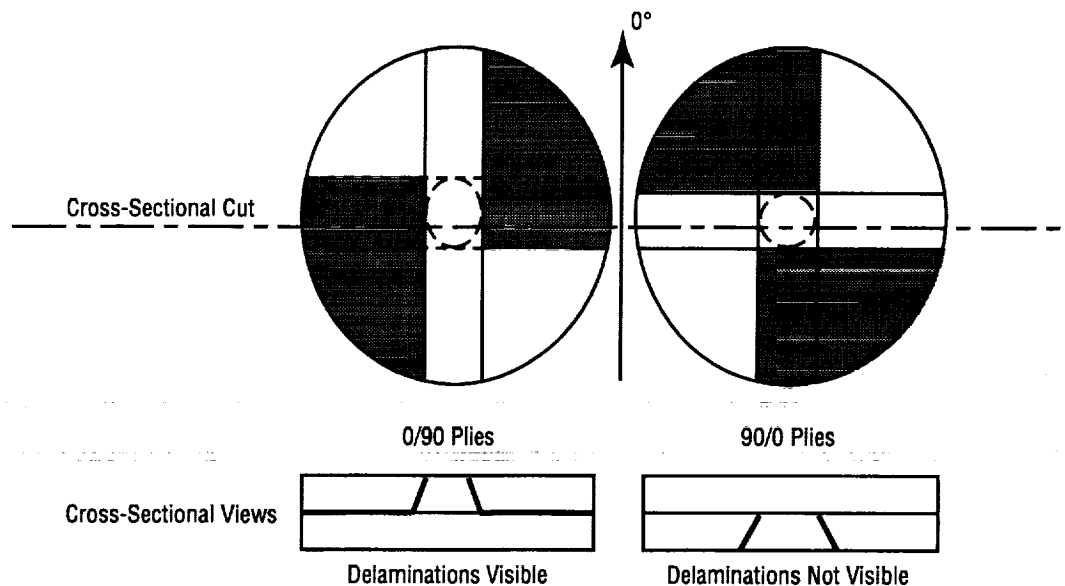
Figure 5. Schematic of cross-sectional view of bidirectional laminates.

verse cracking was observed in the  $90^\circ$  plies and the delaminations were observed only at every other layer. The authors attributed this to the processing of the panel, but as demonstrated in figure 5, this is due to the nature of how the specimen was sectioned coupled with how the delaminations form as shown in figures 1–3.

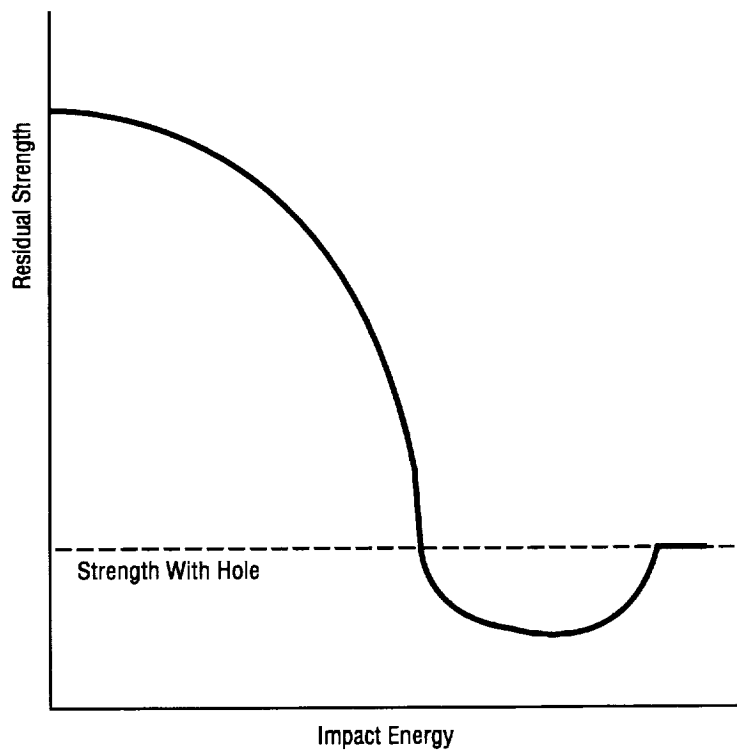
Figure 6. Residual strength versus impact energy curve as predicted by Husman et al.<sup>12</sup>

Husman et al.<sup>12</sup> were among the first to investigate and attempt prediction of the residual tensile strength of impacted coupons. The residual strength prediction was based on an analogy with an inserted flaw of known dimensions and a stress intensity factor for an isotropic material. As a result it was predicted that the residual strength would drop off in proportion to the square root of the impact energy of the projectile. It was noted that departure from this analysis will occur as the specimen experiences complete penetration. Graphically, the residual tensile strength versus impact energy curve as predicted by Husman et al. is given in figure 6. Limited data were given to support this analysis and since ballistic-type impacts were used, the fibers on the impacted surface (which were 0° plies) may have broken at low impact energies (but still high velocities), yielding a drop in residual at the lowest impact energies used in this investigation.

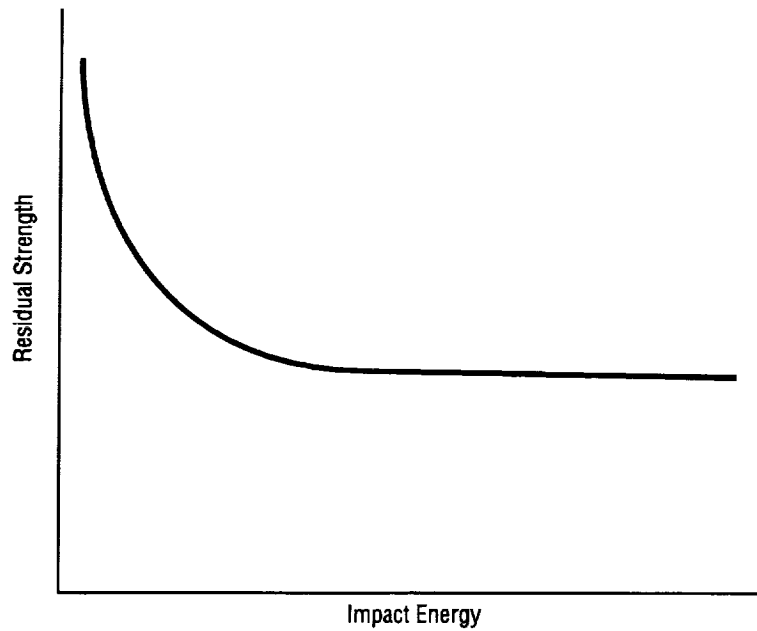
Figure 7. Rapid reduction in residual strength as measured by Rhodes.<sup>50</sup>

Data by Rhodes,<sup>50</sup> also generated by ballistic-type impacts, seems to support the notion that both residual tensile and compressive strengths drop rapidly from the undamaged strength even at the lowest impact energies tested (fig. 7). It is worth noting that these data were from honeycomb sandwich panels whose composite facesheets undergo smaller deflections (due to the backing rigidity of the core), resulting in a more localized damage which includes more fiber breakage.

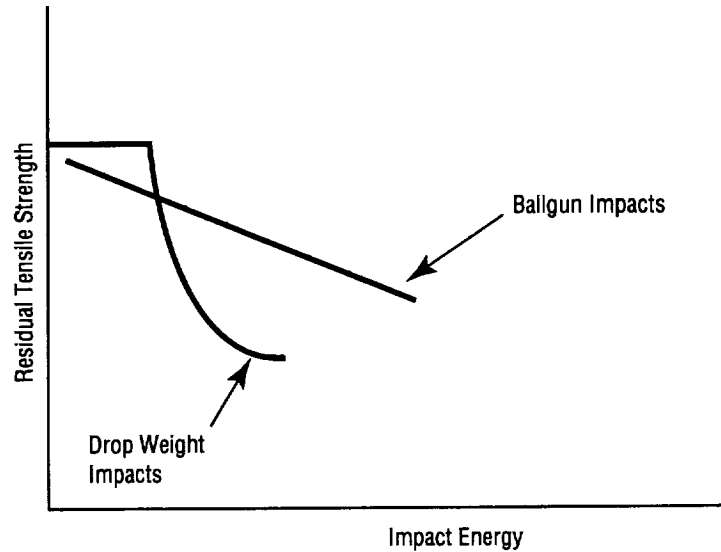
Figure 8. Schematic of residual tensile strength versus impact energy for high- and low-velocity impacts.

Lower velocity impacts, such as drop-weight tests, generate a different material response than high-velocity impacts, as mentioned in sections 2.1.3 and 2.1.4. Therefore, it may be expected that the residual tensile strength response may differ. Comparisons of equal energy high- and low-velocity impacts have been conducted by Adsit and Waszczak<sup>56</sup> and Dorey.<sup>44, 57</sup> In reference 56, carbon/epoxy facesheet honeycomb panels were impacted at low velocities with drop weights and at high velocities utilizing a compressed air gun to project small granite stones. A plot of residual tensile strength versus impactor kinetic energy shows that the strength reduction begins at a lower level of impact energy for the high-velocity stones and also drops off at a faster rate with increasing impactor kinetic energy for the higher velocity tests. In reference 44, the residual strength is seen to drop at a smaller impact energy for ballgun impacted specimens, but once a decrease in strength is seen, it is more rapid for drop-weight tests. This trend is shown schematically in figure 8. This effect is much more pronounced for residual flexural testing as seen in reference 56. The type of resin used can have an effect on these results, as discussed in section 2.3.5.

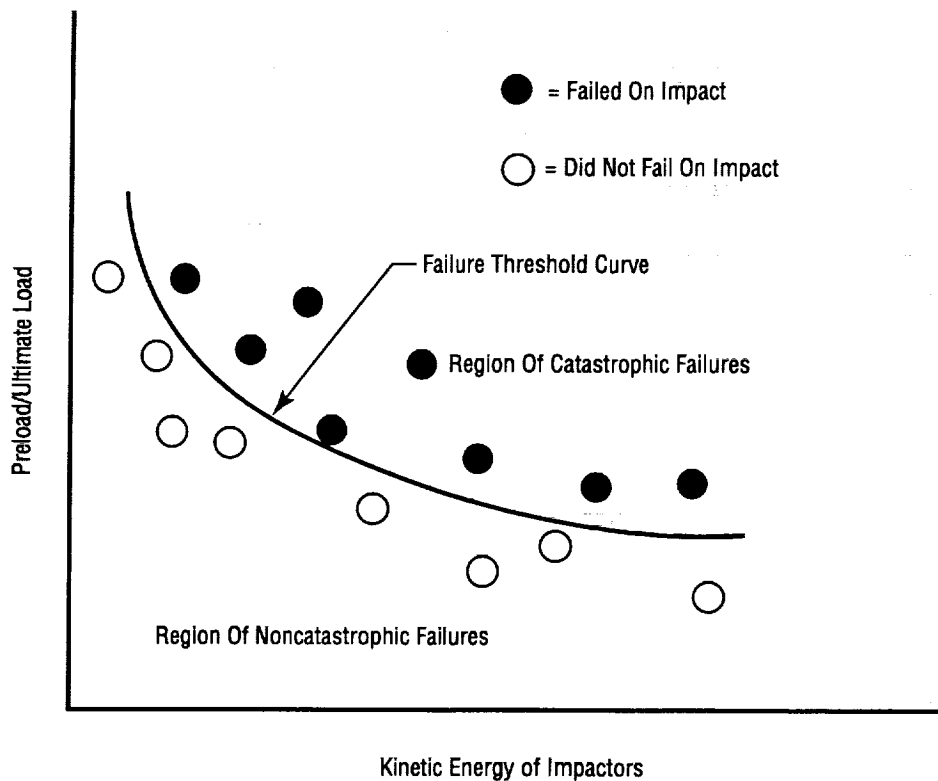
Figure 9. Example plot of preload versus impact energy curve to demonstrate concept of a failure threshold curve.

For nonpenetrating impacts on preloaded specimens, Avva (formerly Sharma)<sup>112-115</sup> has produced the most experimental data on this topic. Typically, a "failure threshold curve" is obtained by plotting specimen preload (tension or compression) versus impactor kinetic energy and drawing a faired curve between the data in which the specimens broke upon impact (a "catastrophic" break) and those which survive the impact. A sample curve (not from actual data) is presented in figure 9 for clarity on this subject. As will subsequently be seen, a well-defined area between the two zones exists in most actual experimental data.

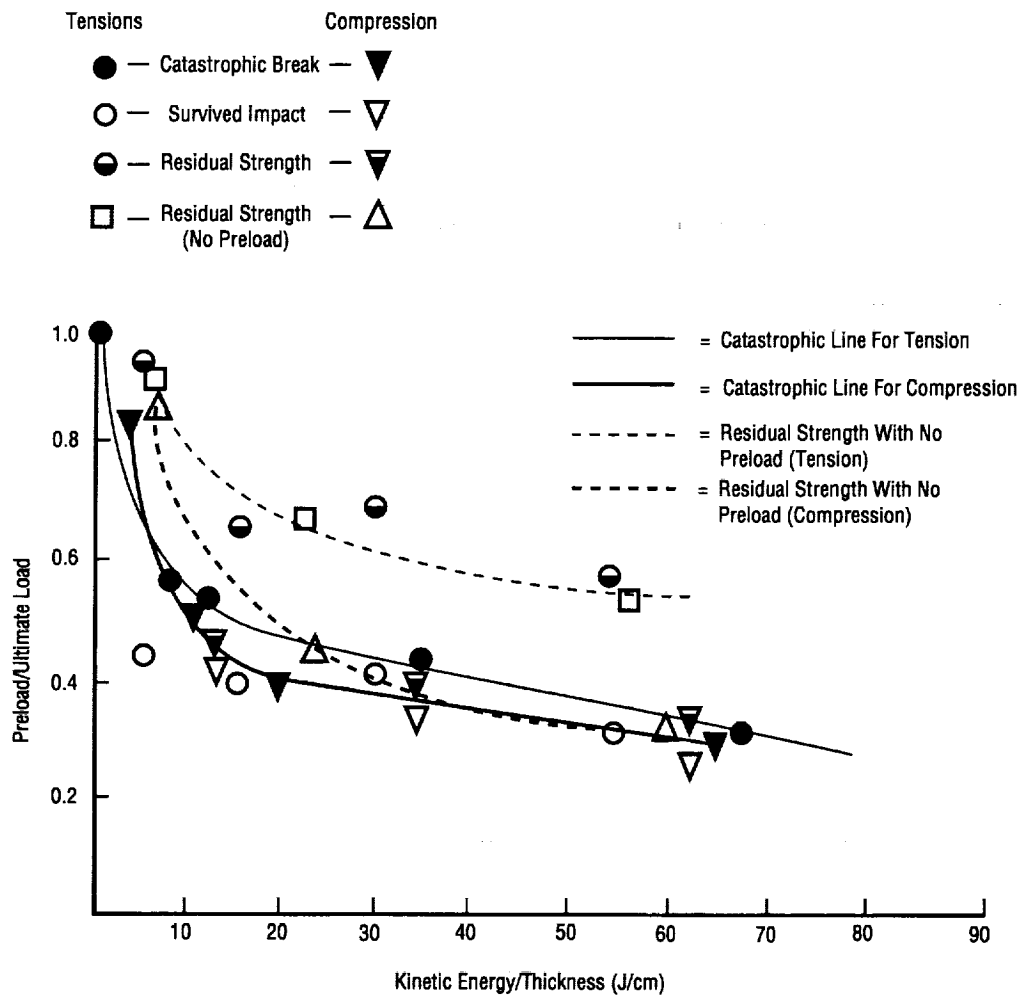
Figure 10. Representative data from Avva.<sup>113</sup>

Similar experiments were conducted for specimens under a compressive preload. For the specimens that did not fail catastrophically upon impact, the residual compression strength was seen not to rise much above the catastrophic failure curve. In addition, the catastrophic failure curve was close to the residual strength versus impact energy curve of specimens impacted with no preload whereas for the tensile specimens, the catastrophic curve was approximately 30-percent lower than the residual strength versus impact energy curve for unloaded specimens. These results are sketched out graphically in figure 10 for clarity and comparison. Only pertinent data points are included to reduce clutter in the plots. Thus, from this study it appears that a tensile preload can reduce the residual strength-carrying capability of the impacted laminate, but only when preloaded near the "catastrophic failure" curve.

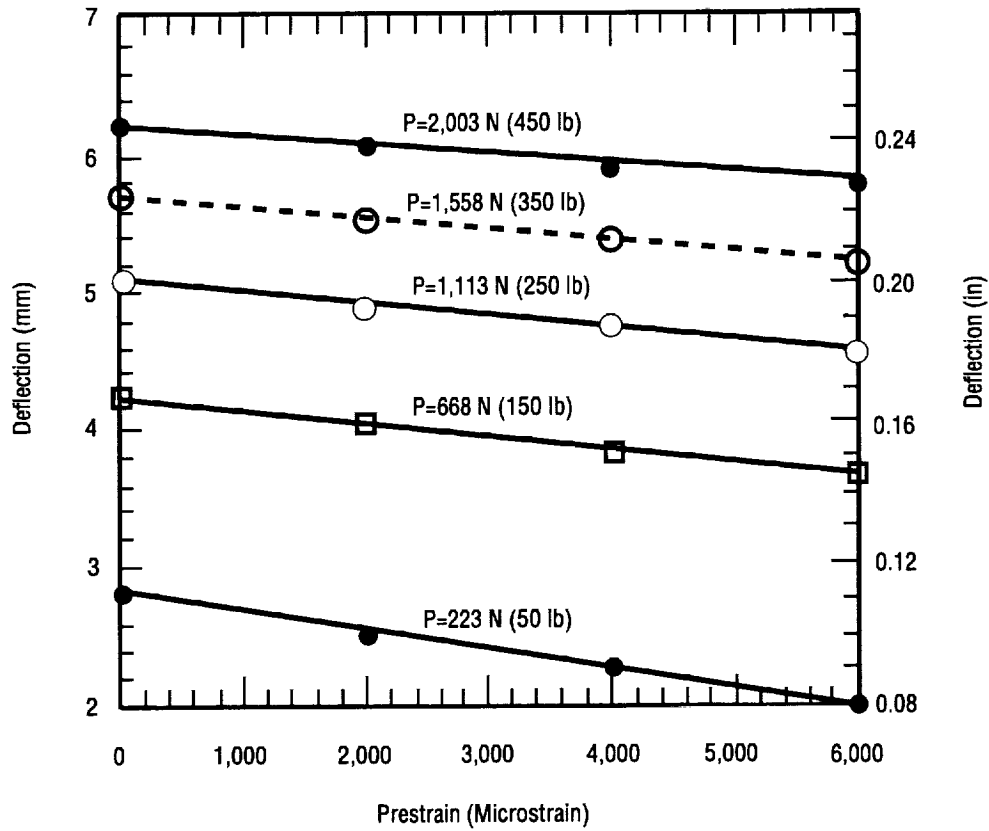
Figure 11. Deflection,  $w_{\max}$ , versus preload for constant values of transverse load,  $P$  from equation (9).

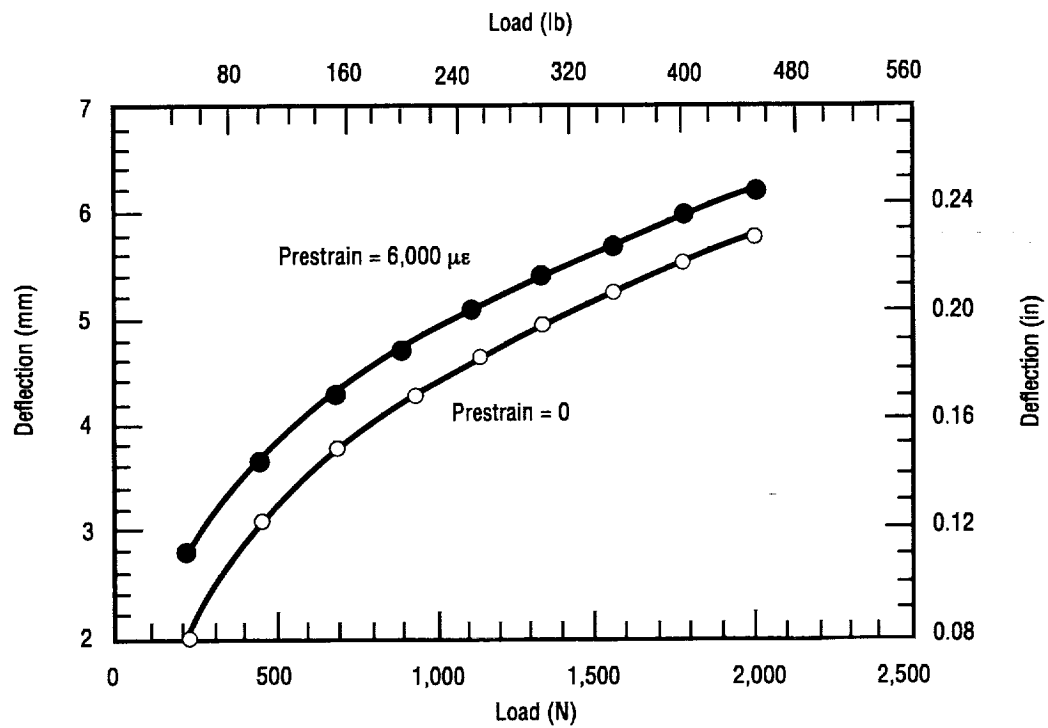
Figure 12. Load versus displacement for constant values of prestrain from equation (9).

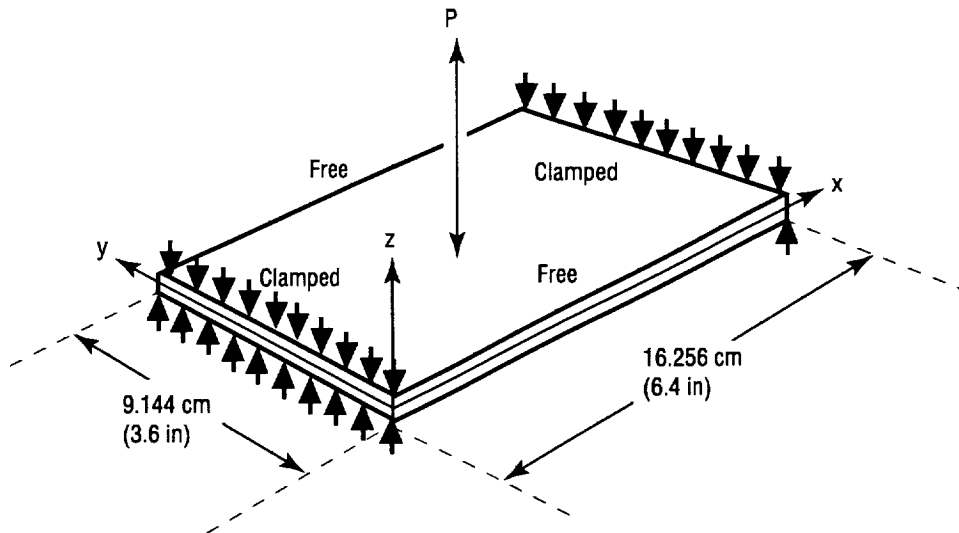
Figure 13. Plate geometry for finite element model.

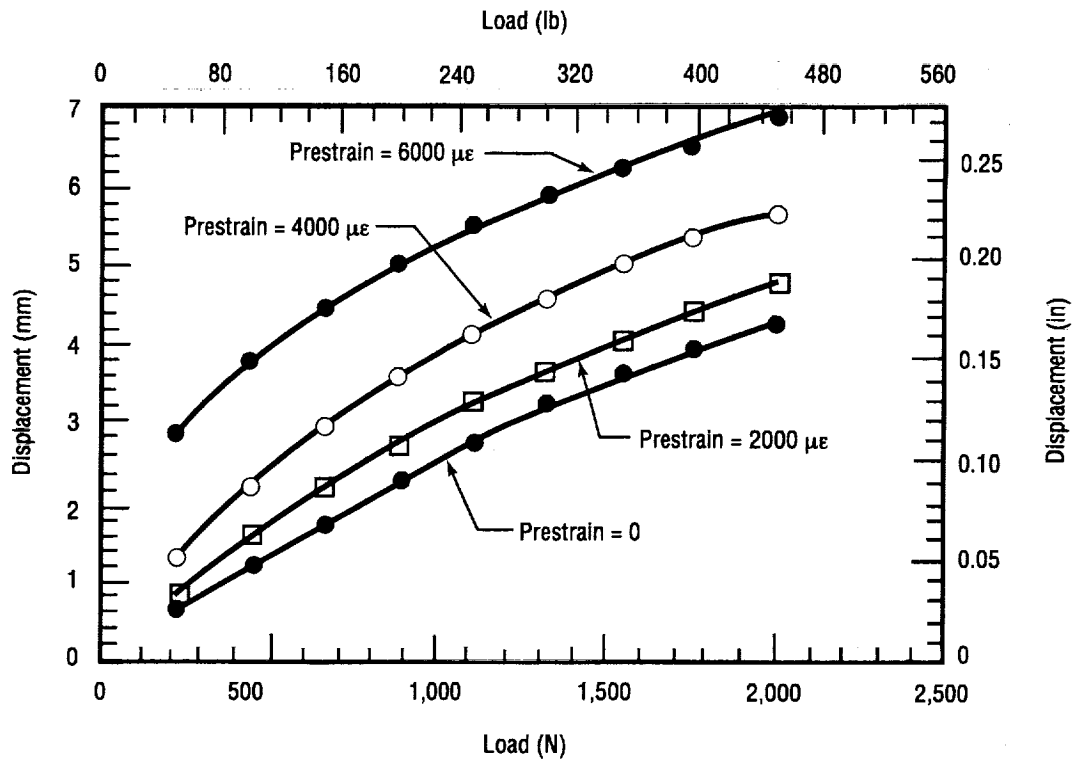
Figure 15. Finite element results for displacement versus load for constant values of prestrain.

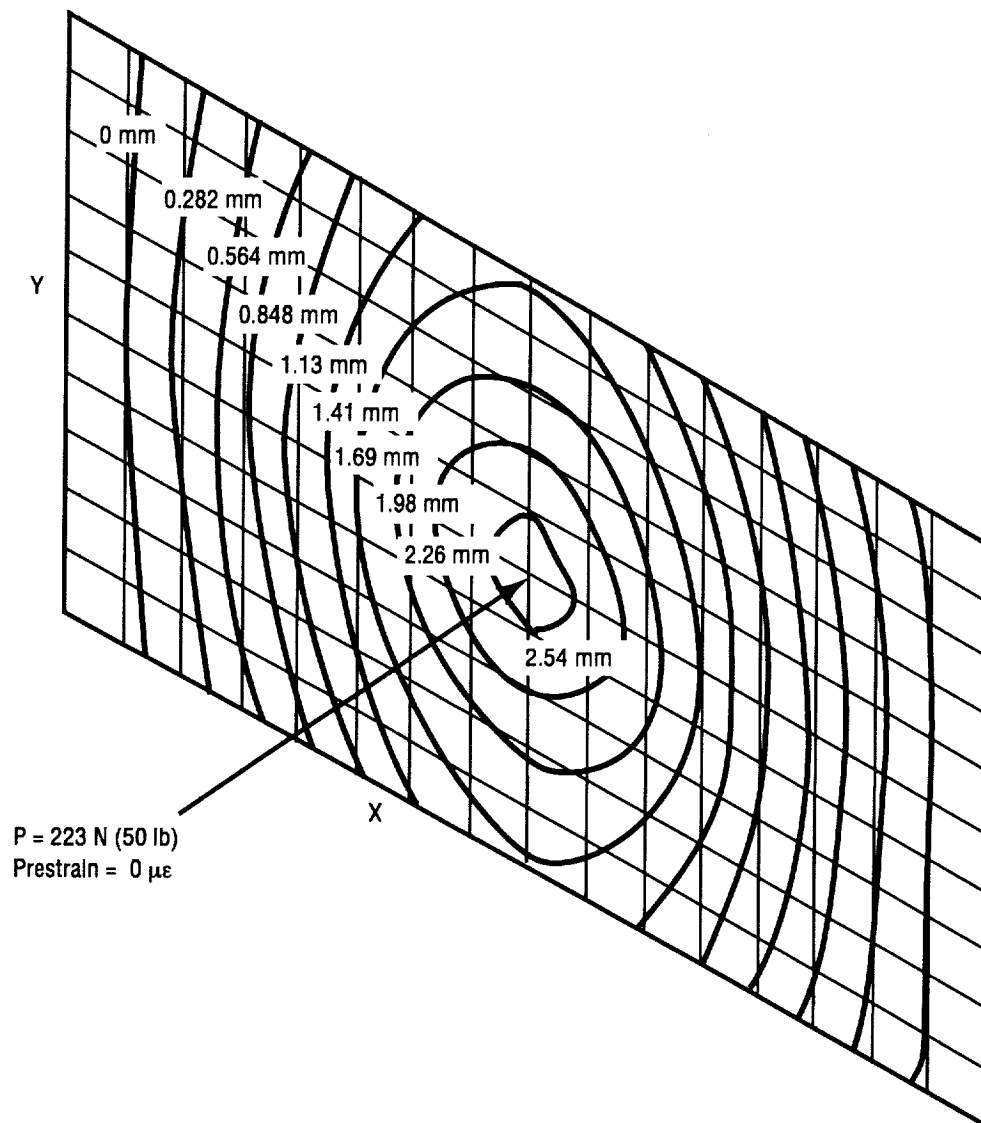
Figure 16. Contour plot of transverse deflection for a transverse load of 223 N (50 lb) and no prestrain.

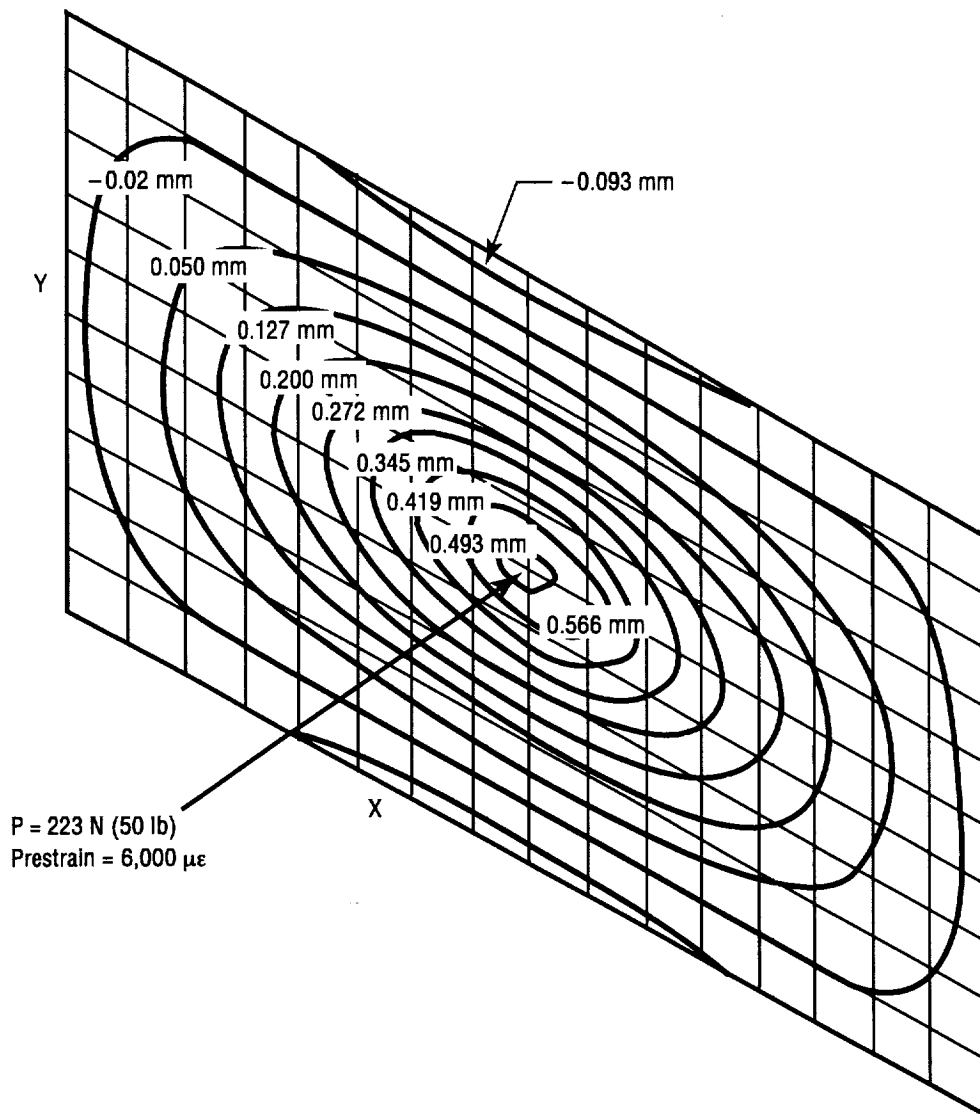
Figure 17. Contour plot of transverse deflection for a transverse load of 223 N (50 lb) and a prestrain of  $6,000 \mu\epsilon$ .

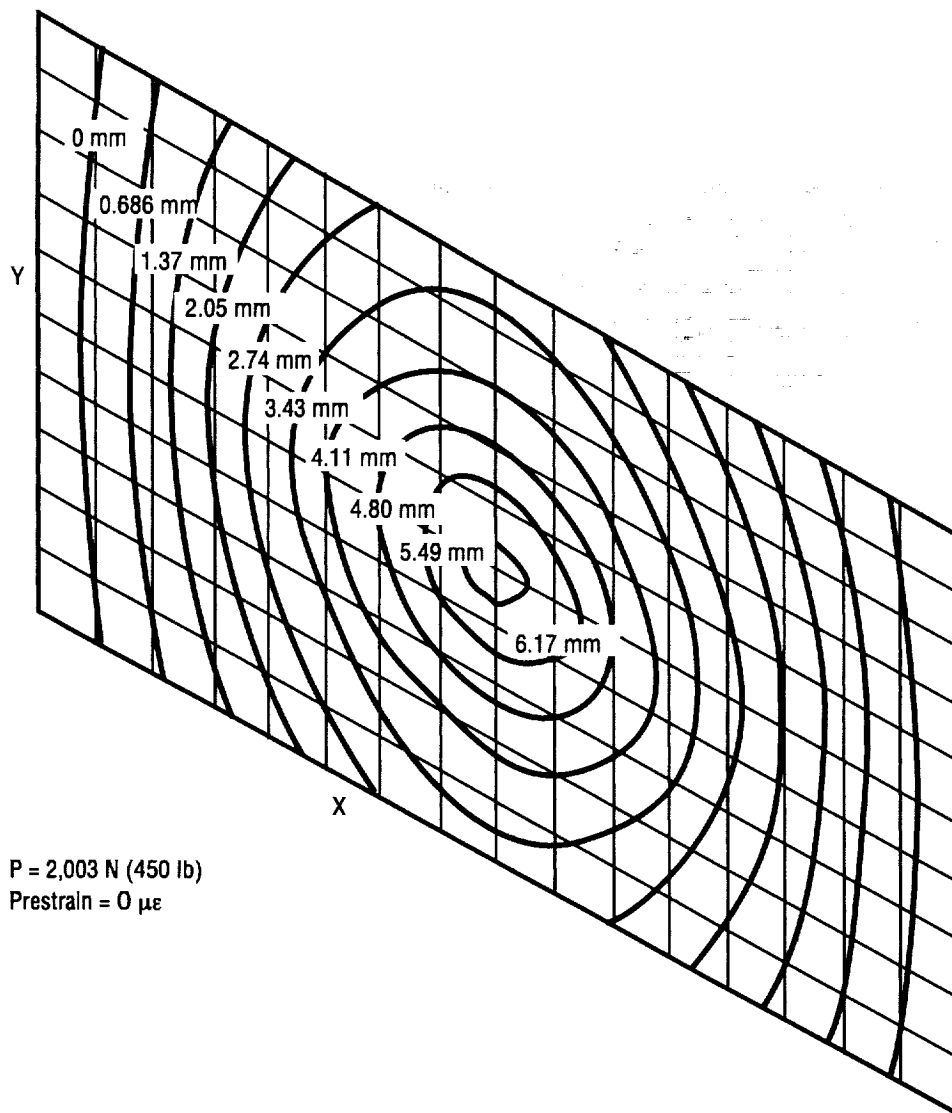
P = 2,003 N (450 lb)  
Prestrain = 0  $\mu\epsilon$

Figure 18. Contour plot of transverse deflection for a transverse load of 2,003 N (450 lb) with no prestrain.

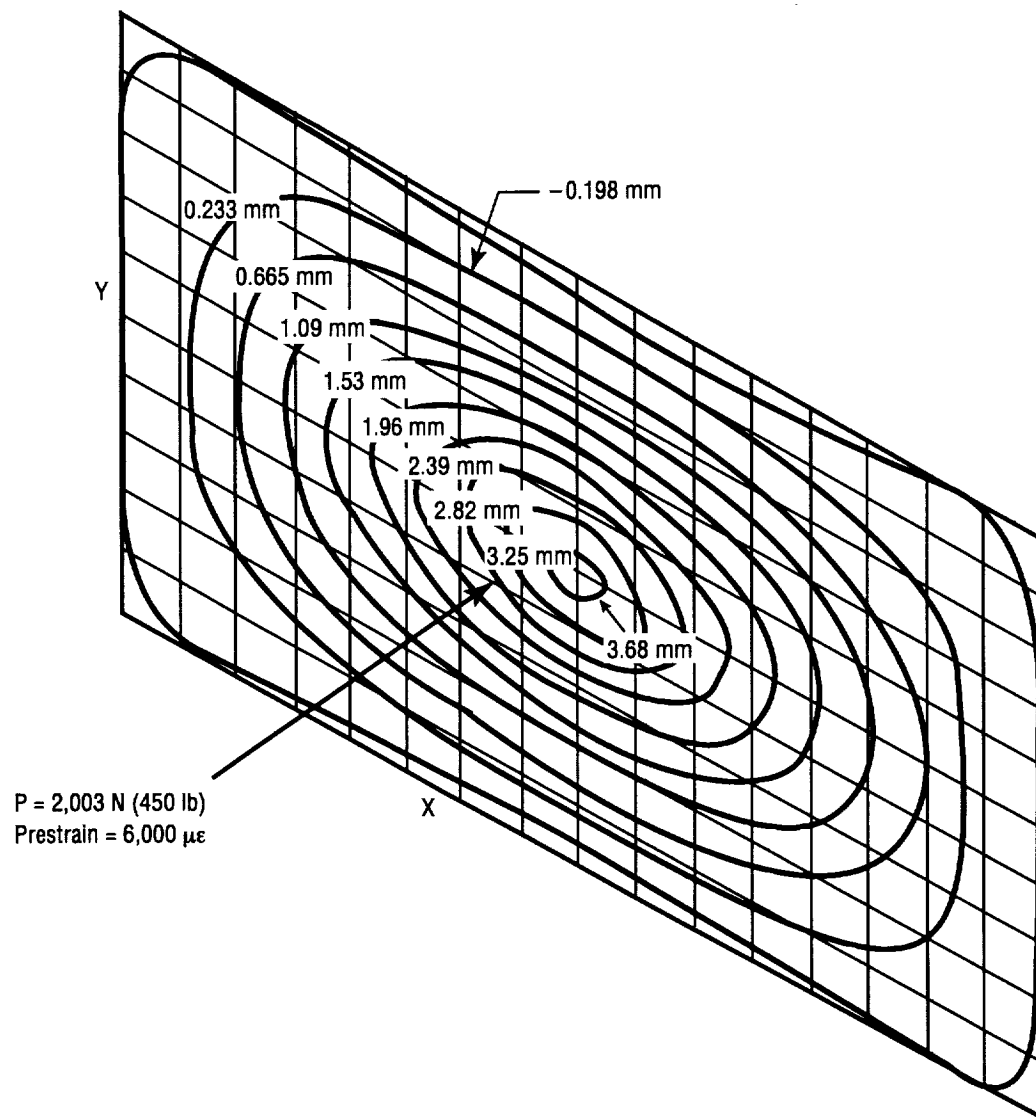
Figure 19. Contour plot of transverse deflection for a transverse load of 2,003 N (450 lb) and a prestrain of 6,000  $\mu\epsilon$ .

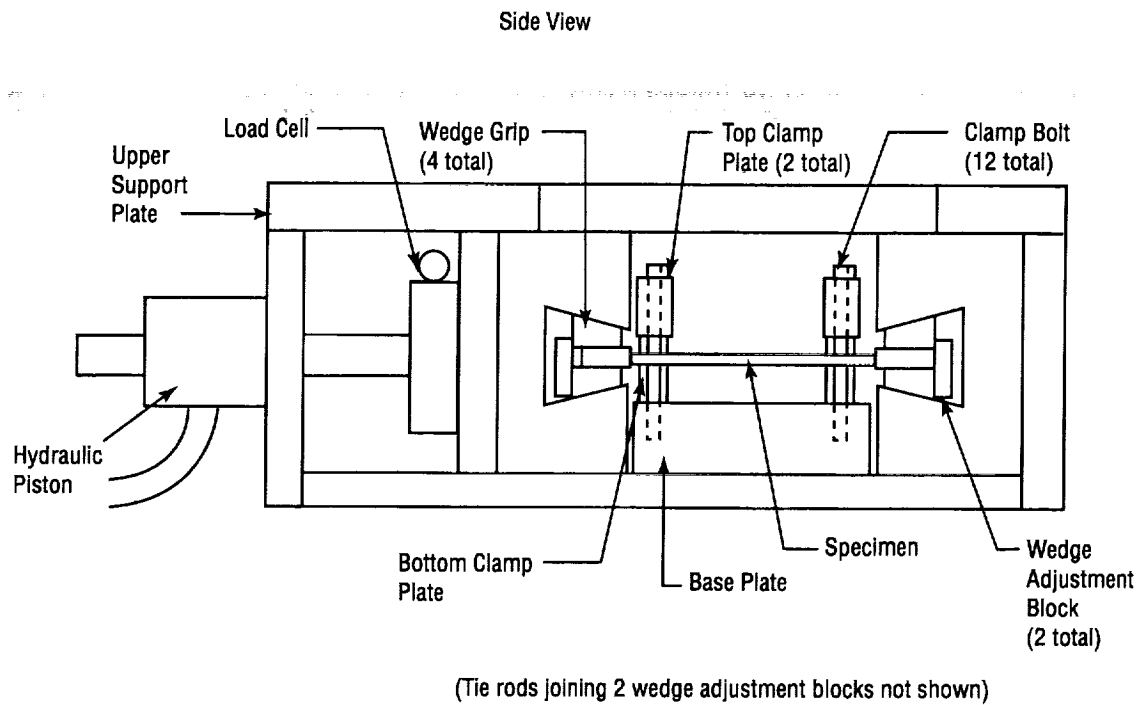
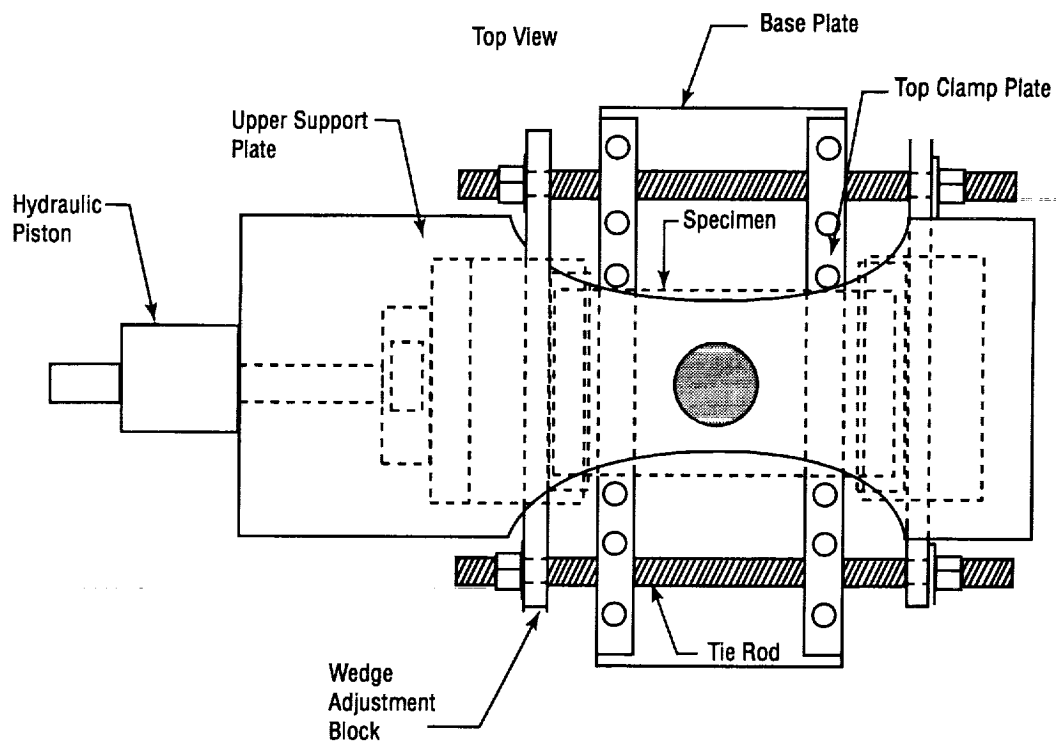
The device to apply tensile preloads to the specimens basically consisted of two wedge grips connected to a load cell and a hydraulic piston. As the piston was pumped with hydraulic fluid it would cause the grips to move apart, putting the composite specimen in a state of tension. A sketch of the apparatus with the various parts is given in figure 21.

Figure 21. Fixture to apply preloads.

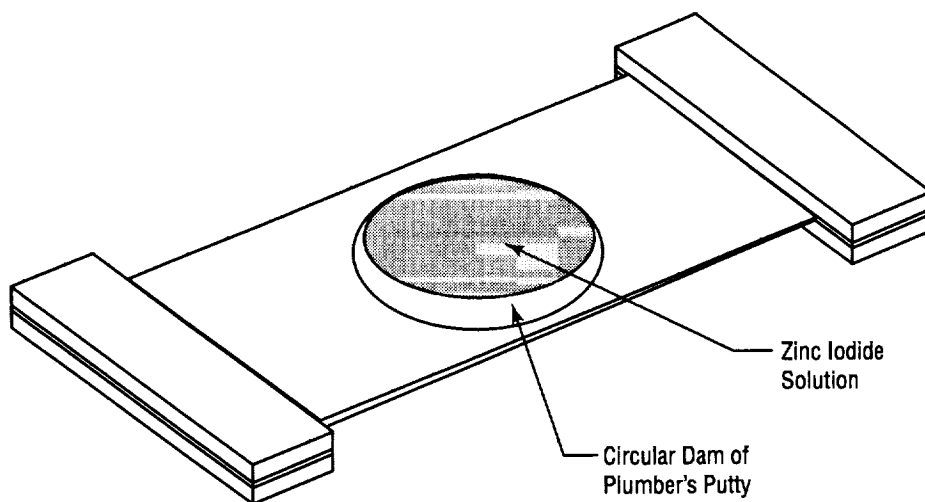
penetrant solution as shown in figure 23. The dye penetrant is opaque to x rays and was allowed to soak on the specimen (at a damage site) for at least 24 hr. The solution consisted of 100 g of ZnI powder in 100 ml of water and 100 ml of Kodak Photoflow™ which breaks the surface tension of the solution to allow full penetration into all cracks and delaminations.

Figure 23. Dam of plumber's putty to hold zinc iodide solution over damage area.

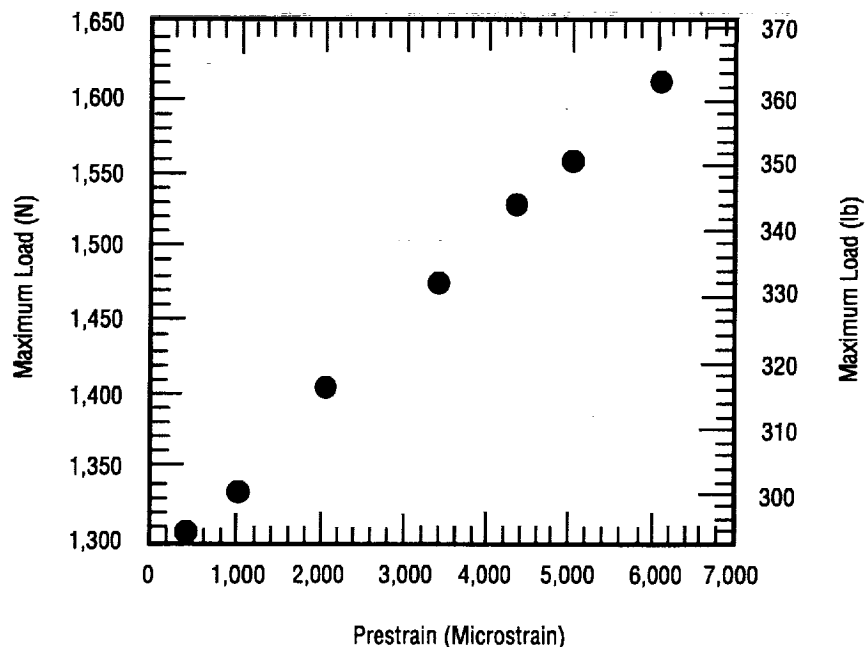
As calculated in chapter 3, the higher the tensile prestrain, the higher the impact force should be for given impact conditions. This was clearly the case for the specimens examined in this study. The results for each of the three impact levels used are shown in figures 24–26. As damage forms in the specimen (not accounted for in the analysis in chapter 3), the maximum load of impact tends to level off, and even drop some with increasing prestrain (which tends to increase the damage).

Figure 24. Maximum load of impact versus applied prestrain for 3.4 J (2.5 ft-lb) impacts.

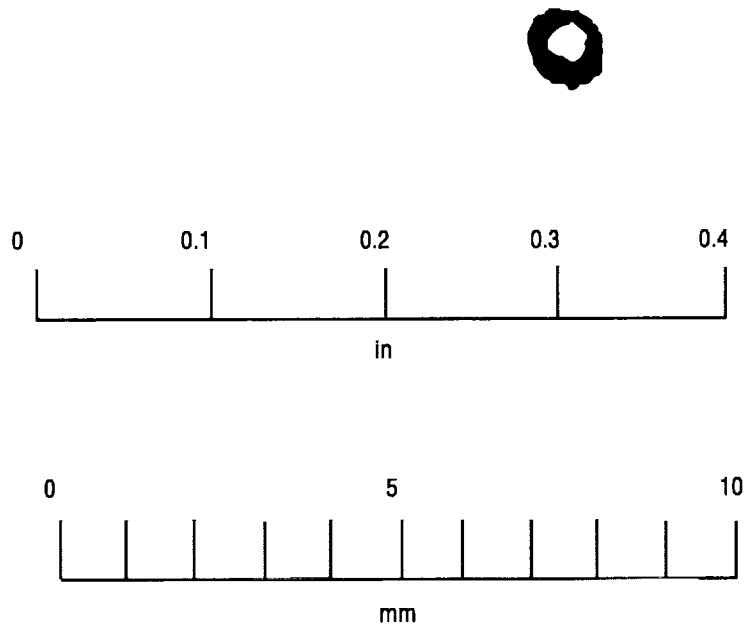
As expected, the specimens that contained more visible damage also contained more internal damage, mostly in the form of matrix splitting and delaminations. The specimens that had no externally visible damage demonstrated that some delaminating occurred (the small drilled hole allowed the penetrant to reach these areas). These delamination zones were relatively small compared to the specimens that had visual damage associated with them. A typical x ray of this type is shown in figure 38. Note that matrix cracking is associated with the delaminations, a feature seen in all of the specimens.

Figure 38. Typical x-ray signature for a specimen that exhibits no visible damage.

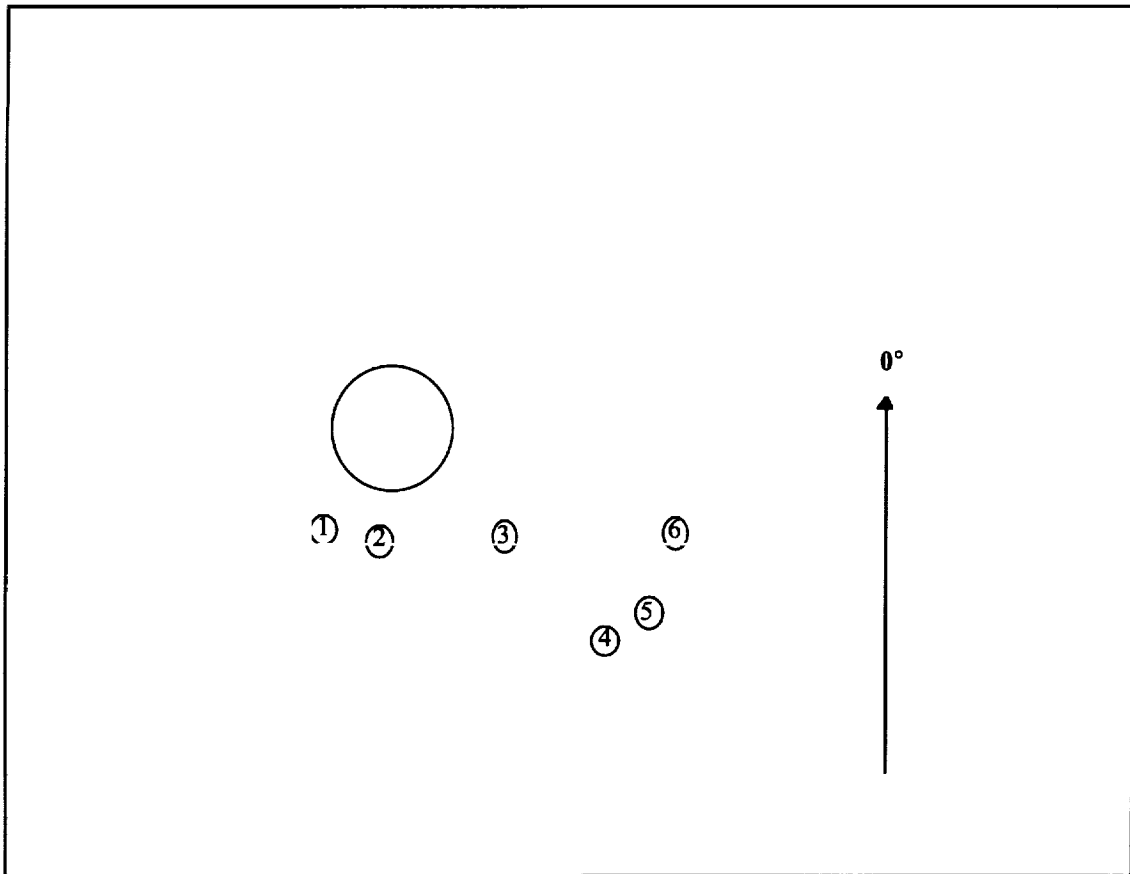
For specimens in which the x rays did not provide sufficient enough detail (usually associated with fiber breakage), cross-sectional examinations proved useful. The x rays gave an accurate description of the damage formed due to the impact event, but fiber breakage was difficult to detect. When specimens were cross-sectioned through the dark areas of the x ray, fiber breakage could sometimes be seen. Cross-sectional photographs of selected specimens, along with their x rays showing where the cuts were made, are shown in figures 41–49. Note that the  $0^\circ$  fiber breakage areas are always in very close proximity to the matrix cracks both above and below this area because these areas are subject to the highest stresses, and also, as a matrix crack forms, the component of stress perpendicular to the fibers in that layer is now transferred to the layer next to it, in the vicinity of the crack.

Figure 41. Cross-section of specimen # Static # 5.

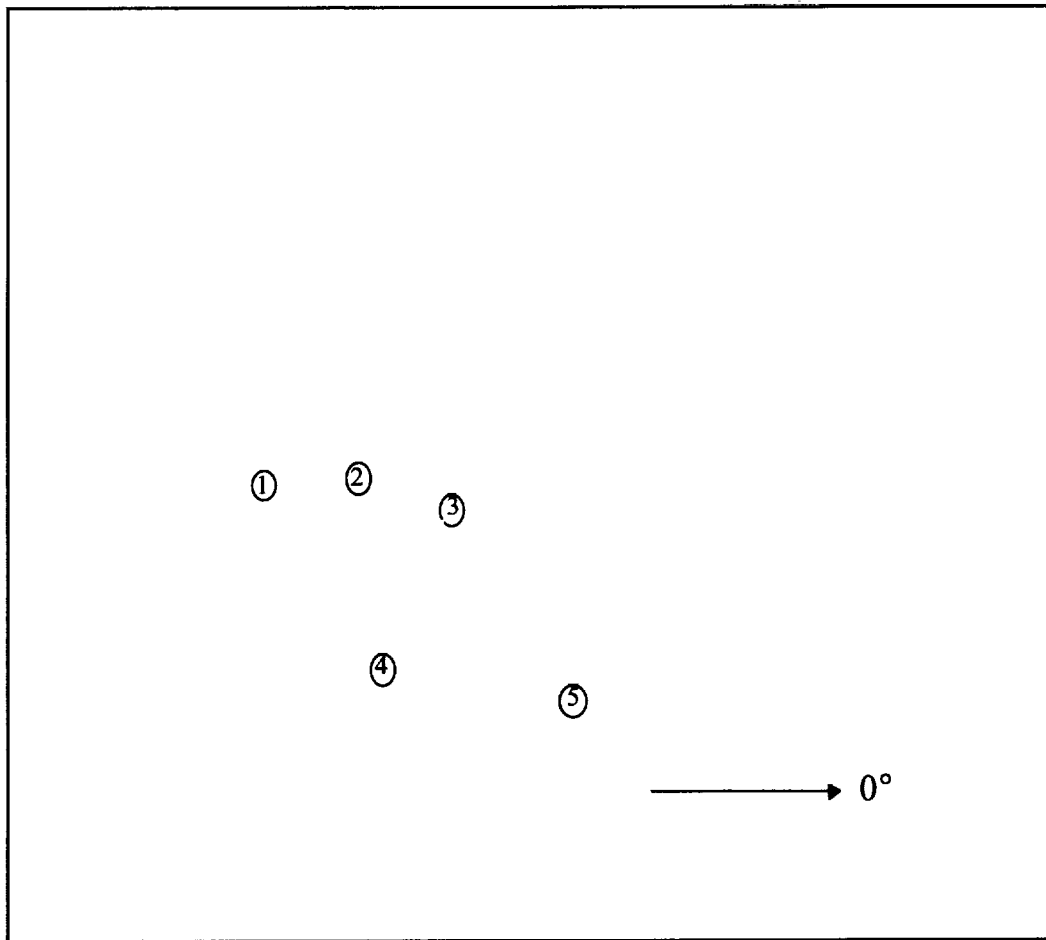
Figure 42. Cross-section of specimen # 12/13B.

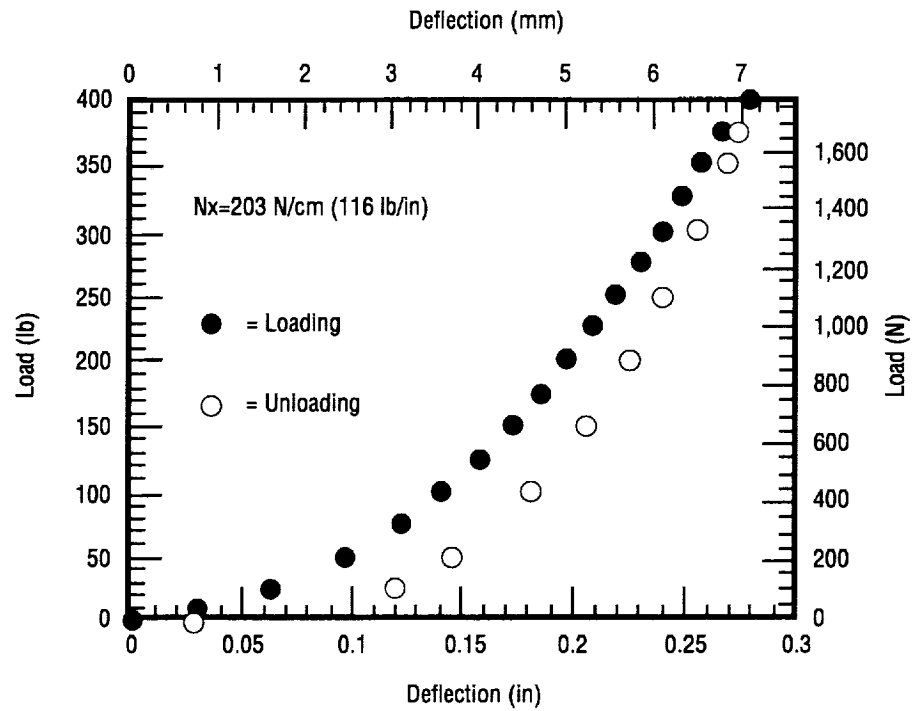
Data from the static indentation tests aided in indicating the shape of the deflected surface as well as showing the different strain fields associated with a low versus a high prestrain. The lower preloaded specimen demonstrated more nonlinearity at the lower end of loading than the heavily preloaded specimen as shown in figures 50 and 51. This is to be expected from the analysis in chapter 3. From the unloading data it is seen that a hysteresis is associated with all of the specimens tested at the lower prestrain levels. This indicates that there is either more damage being formed in these specimens or more compliance in the preloading device at the lower prestrains. Results from the x-ray analysis indicates that more damage was not formed, indicating compliance in the fixture at low levels of preload. Complete data from the 10 specimens tested are given in appendix C (specimen #2 is not included since the dial indicator was not set up properly).

Figure 50. Load displacement from a statically loaded specimen at a low prestrain.

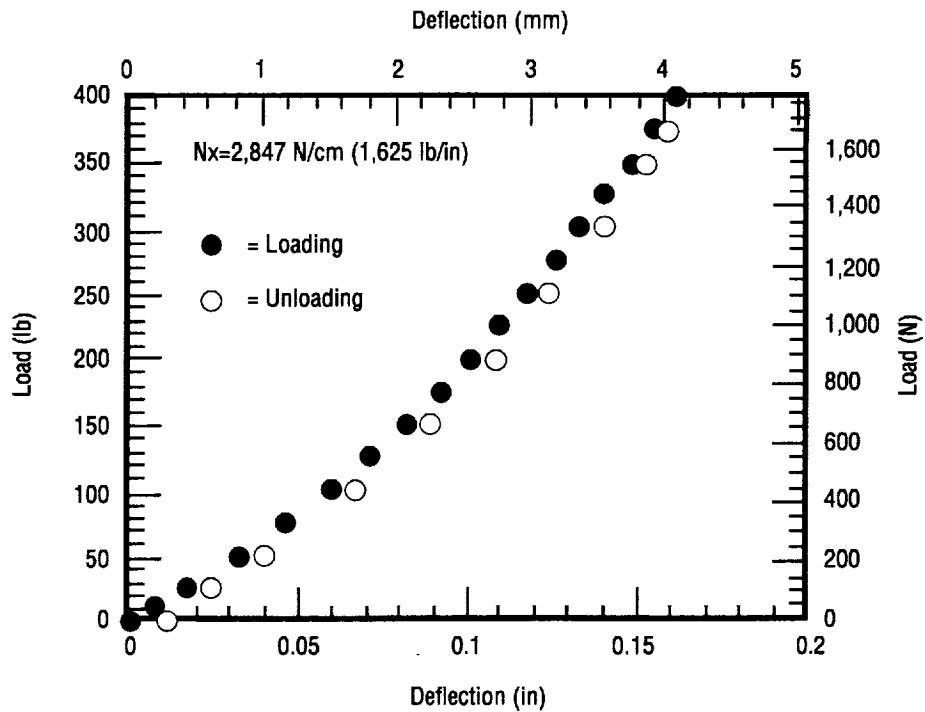
Figure 51. Load displacement from a statically loaded specimen at a high prestrain.
